TECHNICAL REPORT ARPAD-TR-81006

PROFILES OF CRACKS IN BASES OF 155-MM M483A1, M692, AND M731 PROJECTILES

HENRY HARTMANN

APRIL 1982

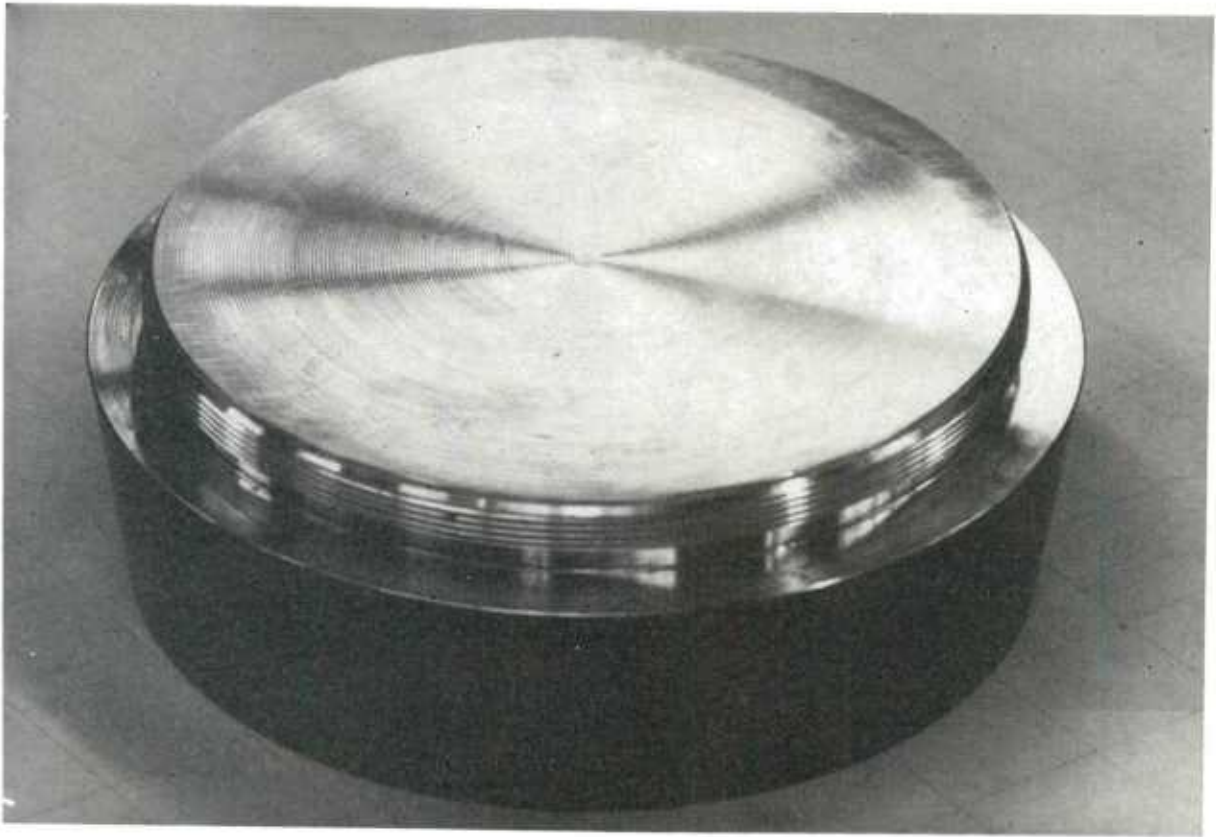
Figure 1. Base for 155-mm M483A1 projectile--forward surface

This report reveals the orientation and depth of many cracks that were found nondestructively in 155-mm M483A1 projectile bases (fig. 1). A total of 63 suspect M483A1 projectile bases were reinspected. As the investigation progressed, two cracked bases for M692 and M731 projectiles were included.

Ultrasonic inspection was done within a water tank which is part of a laboratory scanner. Bases were positioned under water in the center of a turntable. The forward surface of each base (fig. 1) was facing up. This position trapped air inside the rear cavity within the boattail. Care was taken to prevent any splashing inside the rear cavity (fig. 2) while each base was being placed on the turntable (fig. 3). Any droplets of water on the rear face of a base could cause false defect signals.

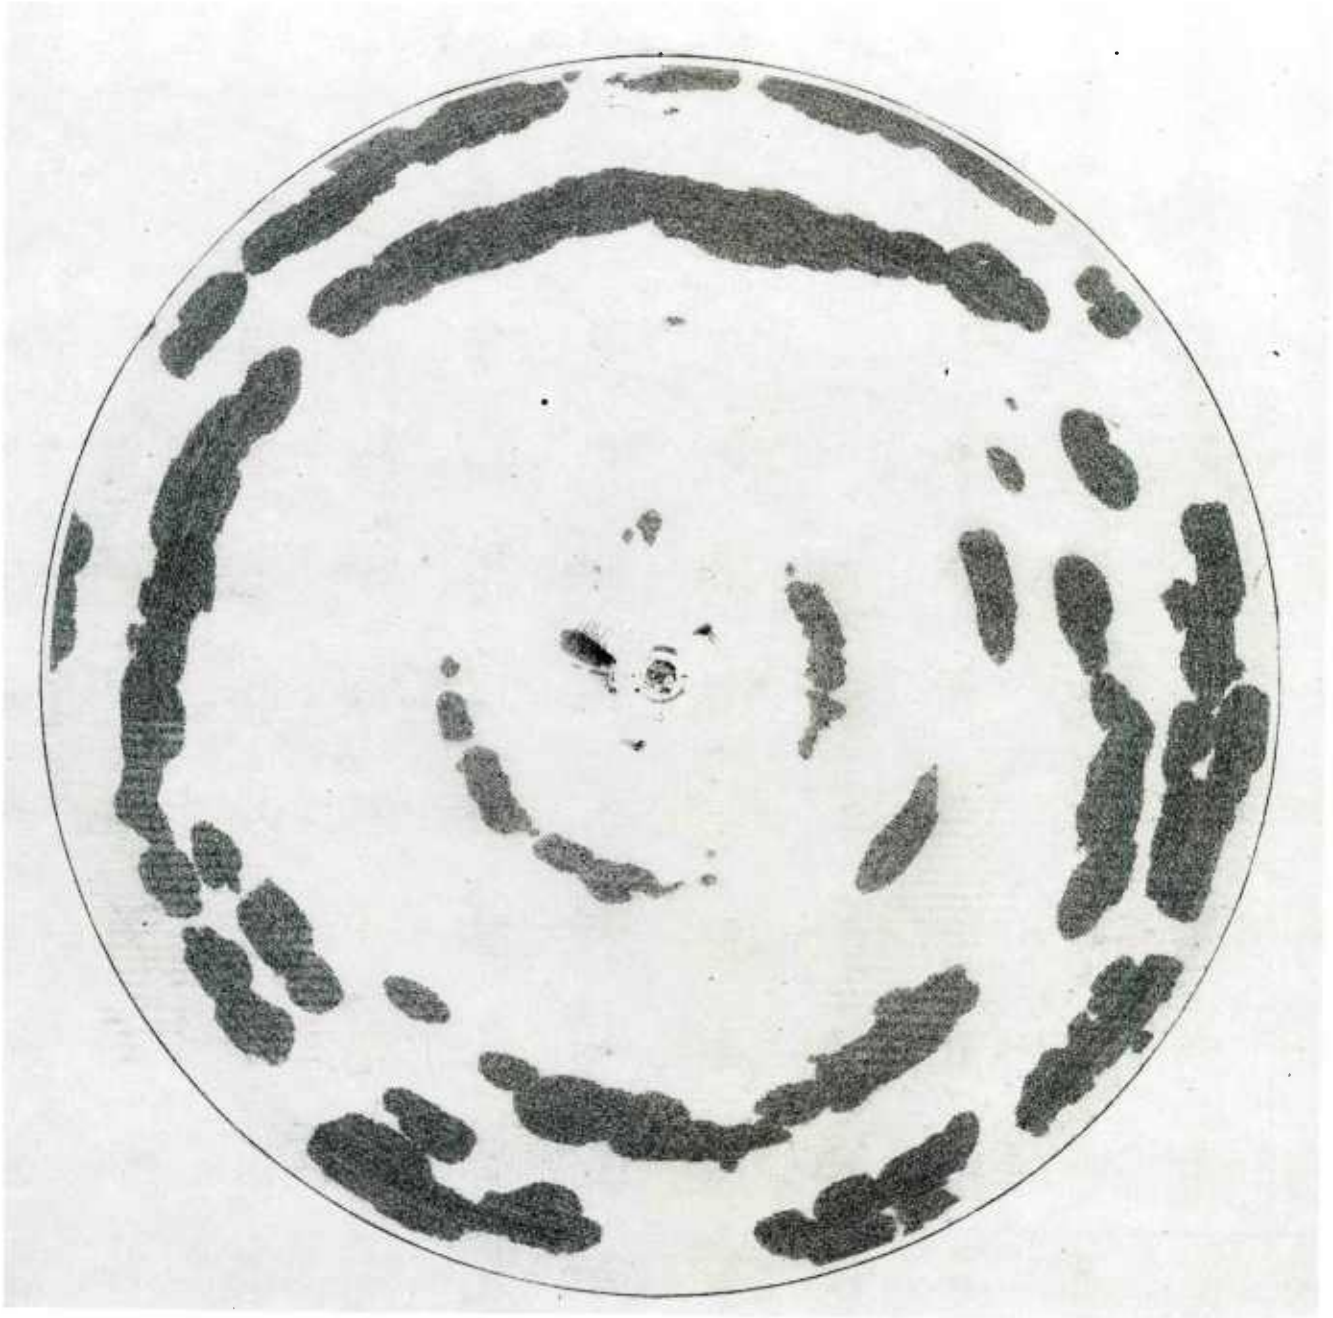
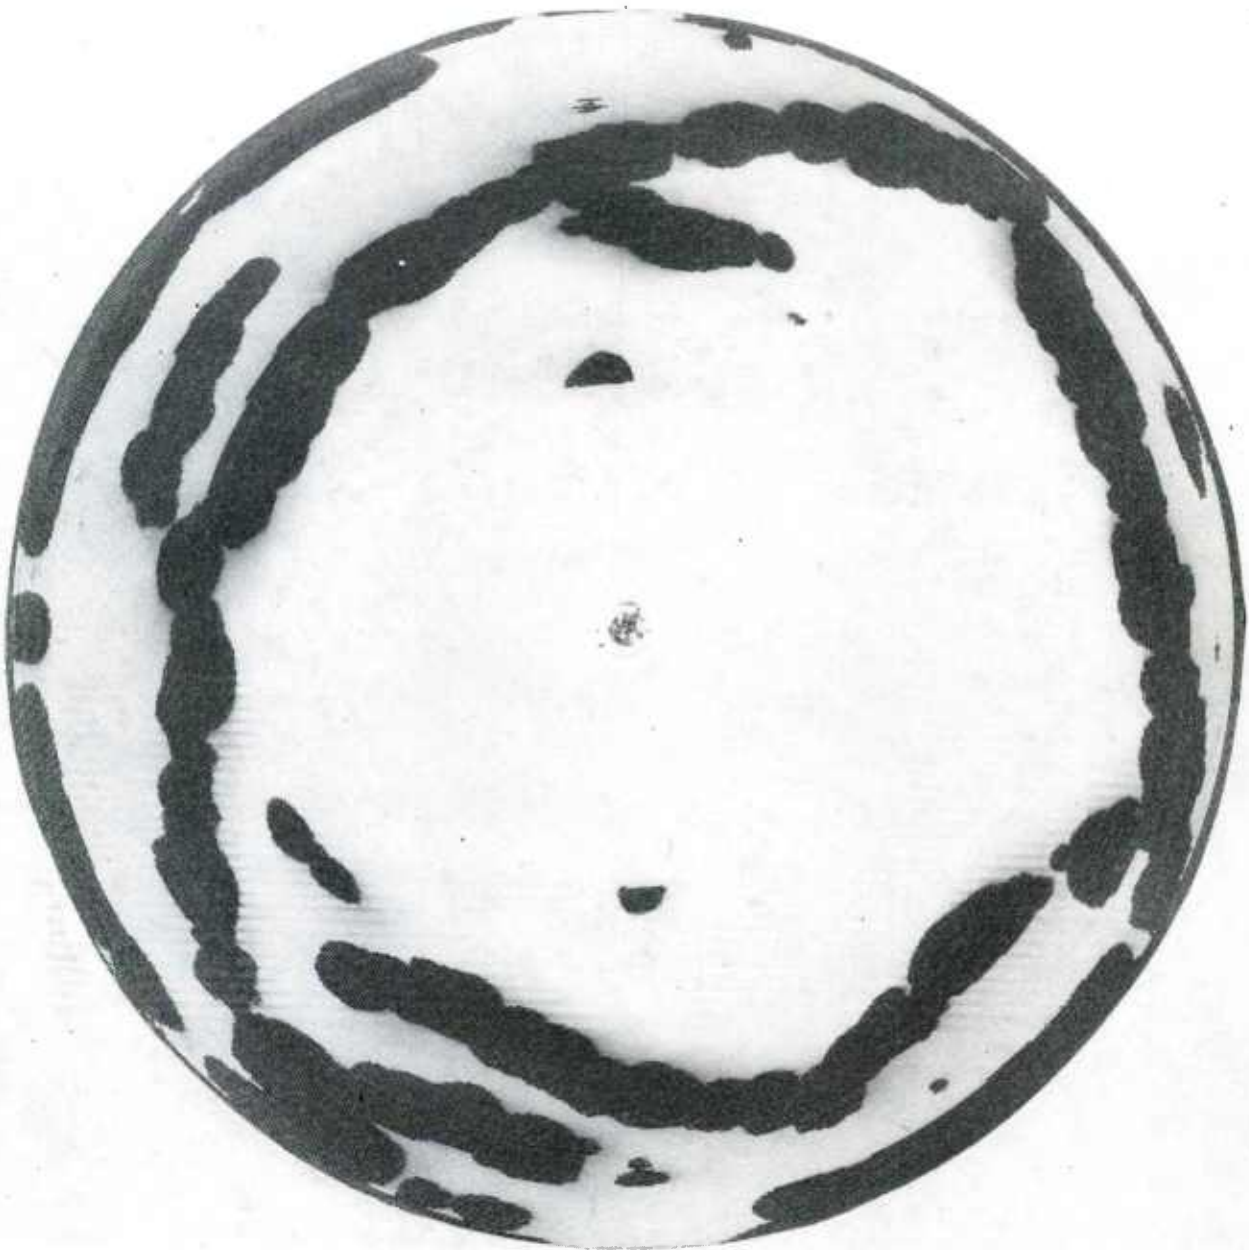
Ultrasonic C-scans were made of all bases. Most of the C-scans which showed flaws (figs. 6 through 29) are included in this report. All detected flaws were on the forward surface of the bases. The gain setting for the ultrasonic flaw detector was 50 decibels. A sample calibration using the standard is shown in figure 30.

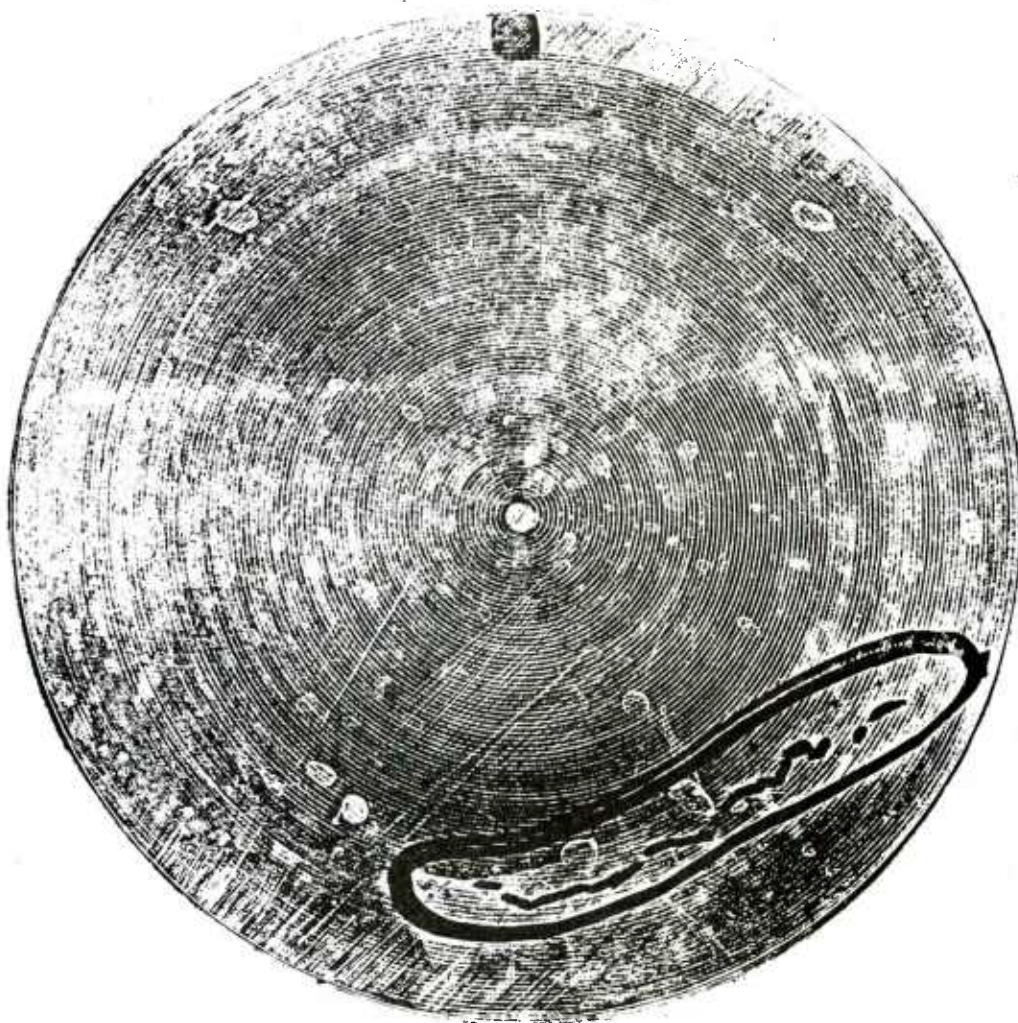
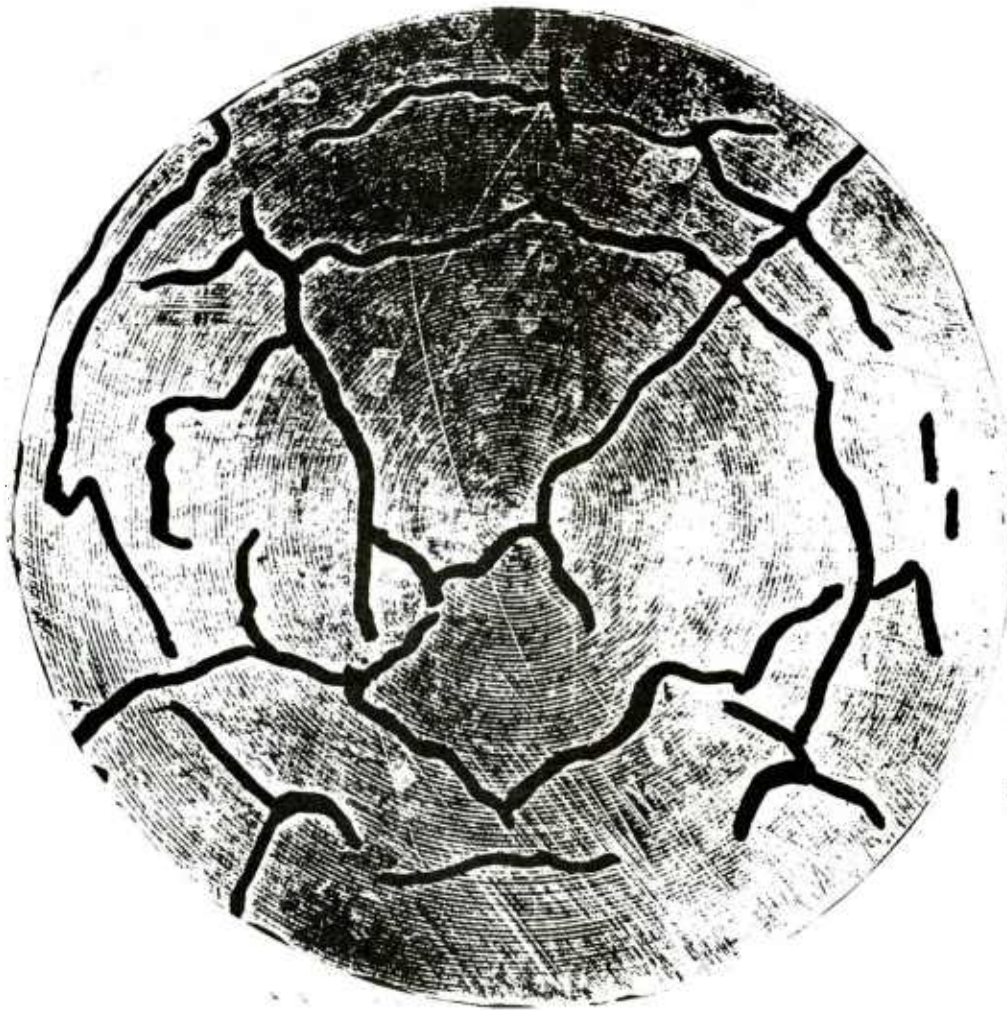
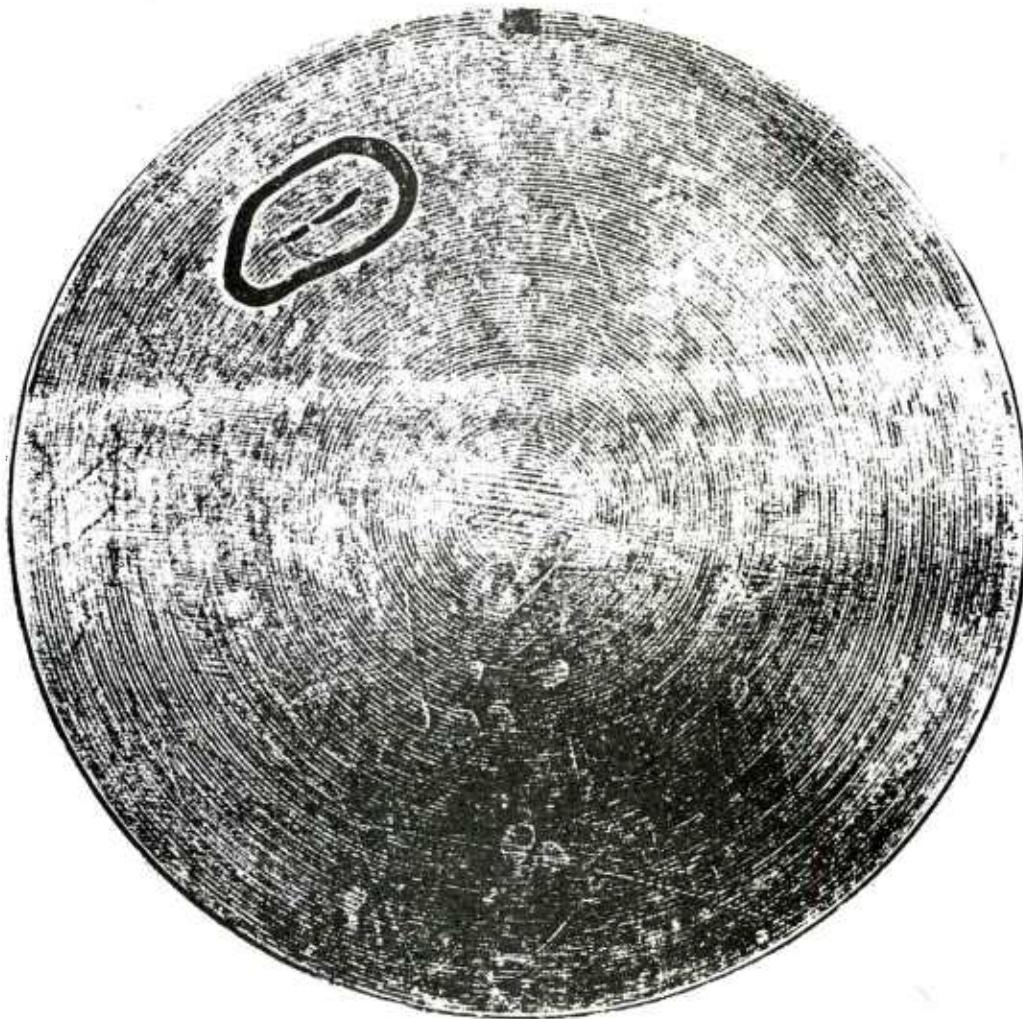
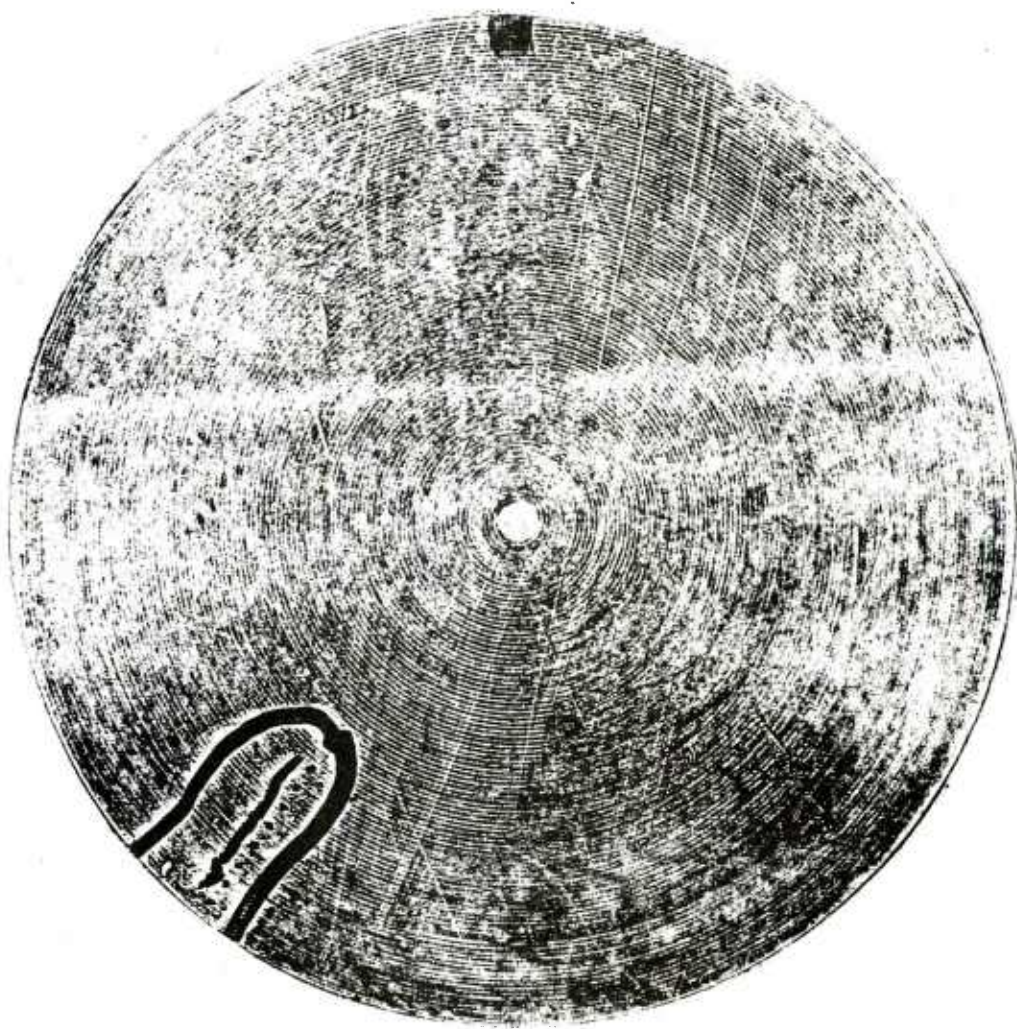
Eleven bases were inspected with fluorescent liquid penetrant (table 3). Five of these bases were known to have cracks. Four revealed their cracks (figs. 44 through 47). Base no. A-CMC/LAAP 4 did not reveal its crack. It was later found with eddy current inspection (table 2) that this crack was small, having a length of 10 mm (0.4 in.) and a maximum depth of 0.6 mm (0.02 in.). The other six bases had spots. Only three of these spots (all in base no. CMC/KAAP 76) were revealed by fluorescent liquid penetrant (fig. 48). This occurrence hints that the spots in the other five bases were beneath the surface.

The flaws revealed by fluorescent liquid penetrant were recorded by marking over the indications with a black felt-tip pen. The same pen was used with eddy current inspection to outline the other flaws that were not revealed by fluorescent liquid penetrant.
